CHAPTER 2. LAND RESOURCES

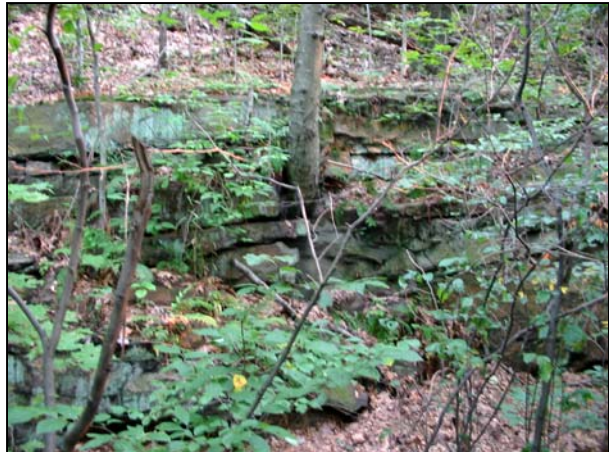
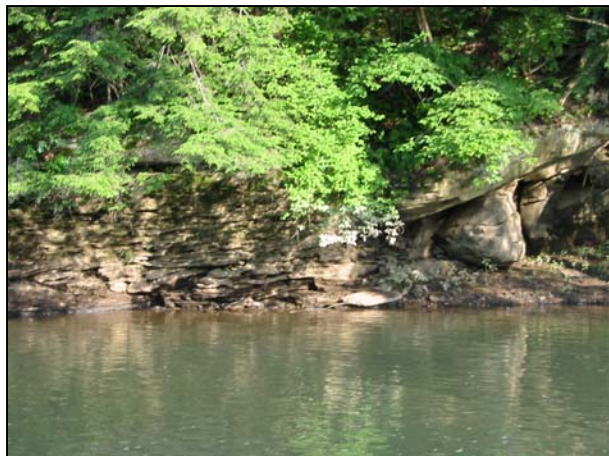
Rock formations in the Lower Crooked Creek (below) and Tub Mill Run (above) watersheds

Surface rock strata within the watershed include the Conemaugh Group on the uplands and the Allegheny Group along the valley sides of Crooked Creek and its larger tributaries. Both the Conemaugh and Allegheny Groups include sedimentary rocks – sandstone, shale, clay, limestone and coal. There is considerable interpoding of these beds and intermediate forms are common.

The economically important coals, clays, and limestone are all part of the Allegheny group of rocks. The important coals include: the Upper Freeport, Lower Freeport, Upper Kittanning, Middle Kittanning, and Lower Kittanning. These coal seams have been mined by surface and underground methods. Both methods are being actively employed in the watershed today.

The main limestone bed is the Vanport limestone and is being actively mined near South Bend and at a site between Girty and Cochran's Mills. Sandstone is also being quarried for riprap and aggregate at the South Bend site.
